## Geotechnical Investigation for Proposed Private Plan Change at Fonterra Te Rapa, Hamilton

Rev A1

4 December 2024

Job No. 220489

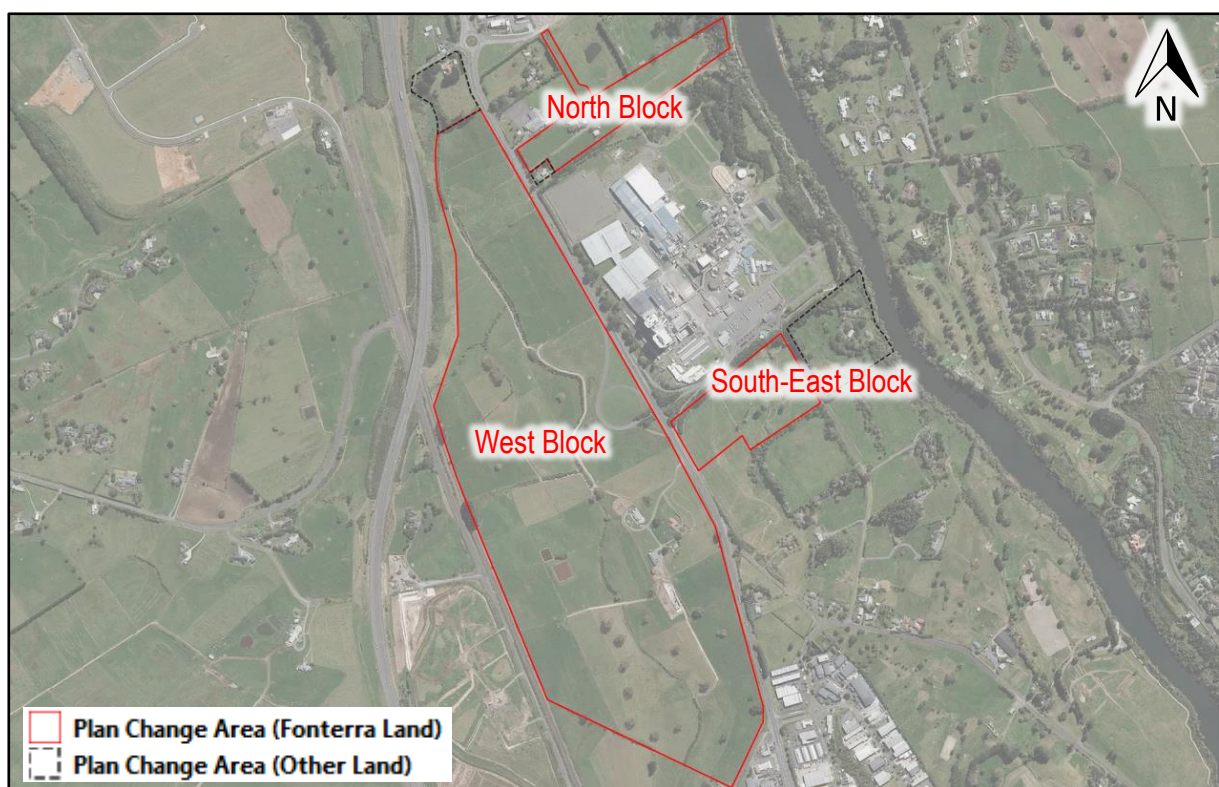
Figure 1: Plan Change Area (Underlay Source: LINZ Data Service)

Due to site access constraints, our investigation was limited to the land owned by Fonterra at the time of our investigation and did not extend to Section 1, 3 SO 456626 (West Block), Lot 1 DP8230 (North Block), and Lots 1-2 and 3 DPS 61136 (South-East Block). The Plan Change Area extent is shown in Figure 1.

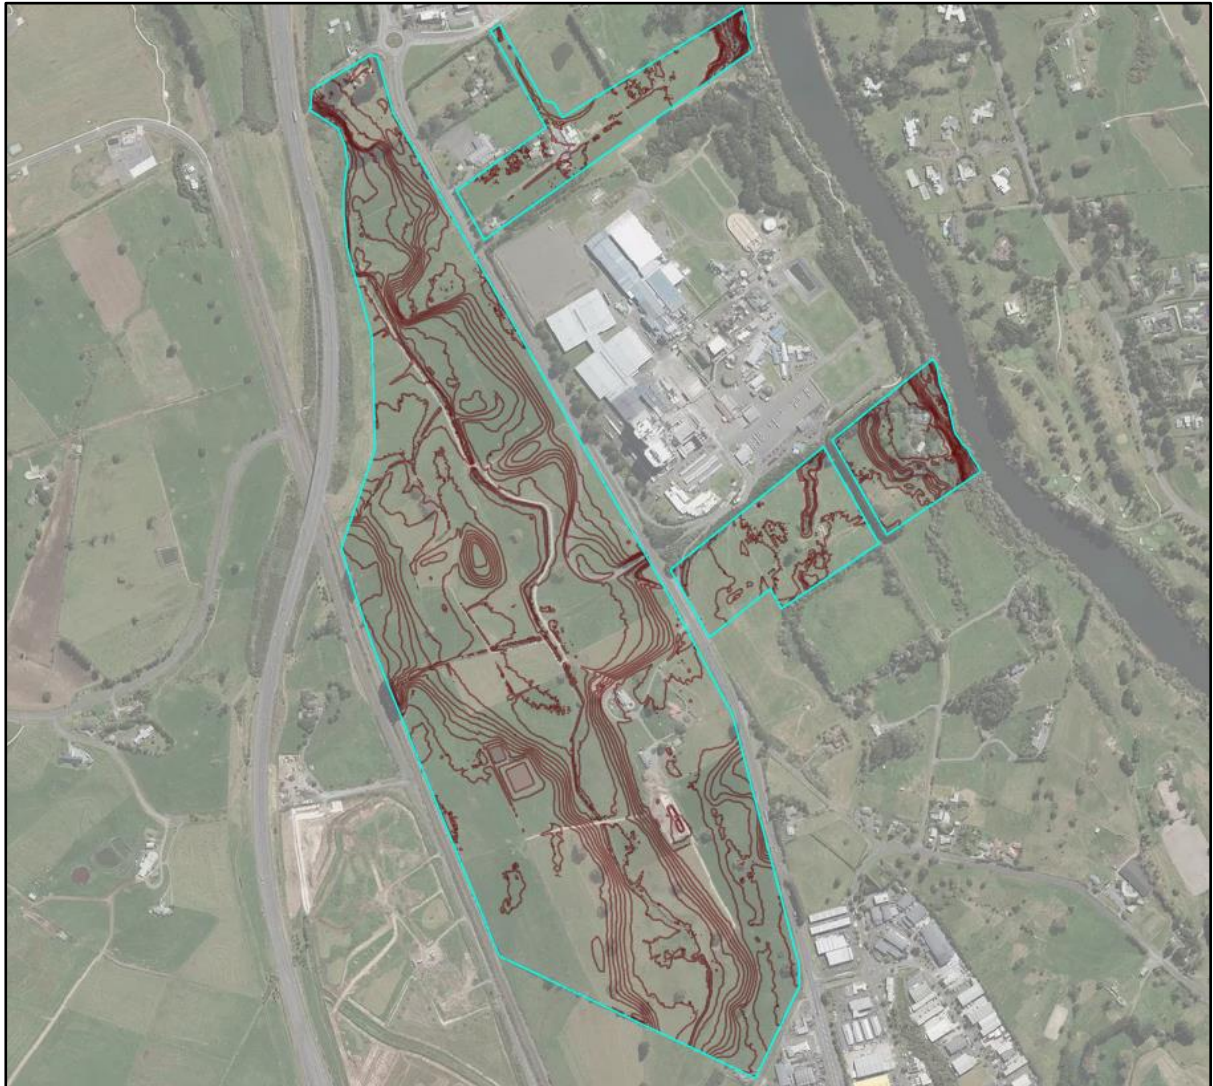
**Figure 2: Plan Change Area Contours – 1m Contour Intervals** (Source: LINZ Data Service)

The topography broadly comprises a central near-level floodplain (see Figure 2) with the slopes of the floodplain descending towards the stream at inclinations generally ranging between  $<10^\circ$  and  $18^\circ$ .
